# Kaimai Tunnel – a report on the Safe Working Procedures Review

A joint working party report by KiwiRail and the RMTU, March 2014

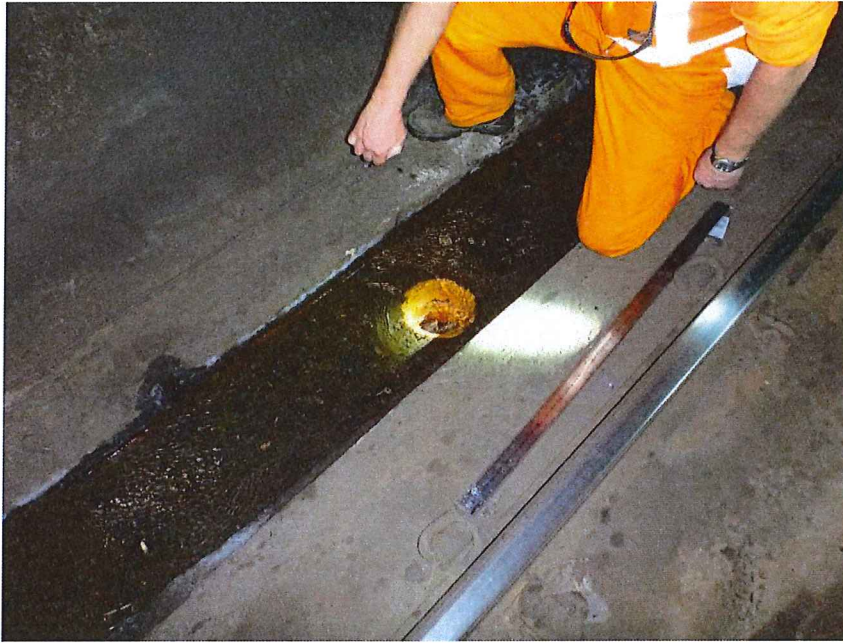
**Figure 4: Tunnel drain**

A significant amount of water runs through the tunnel. The tunnel drains east to west. The circular profile of tunnel drains are nominally 228mm deep and 230mm wide at the base.

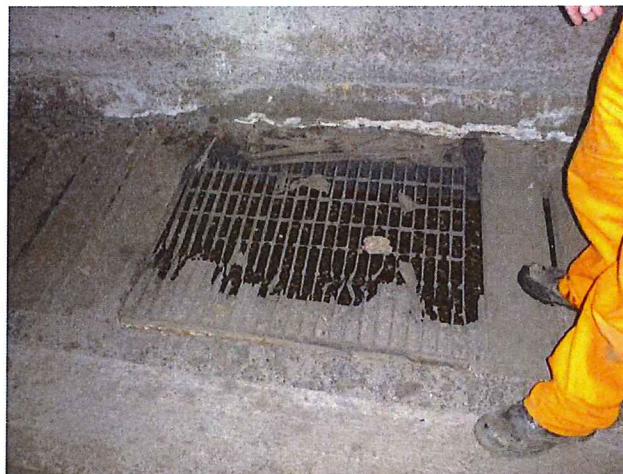
**Figure 5: Drain cover in the tunnel**

Timber cover walkways are rotting in some places and have been removed in others. They are suffering from age and subsequent deterioration. The AMP has recommended that the timber side drain covers be replaced with steel grating through the horseshoe section.

**The Review agrees with the AMP and recommends** replacement of the drain covers to provide a safe environment for track workers and safe access for LEs in an emergency.

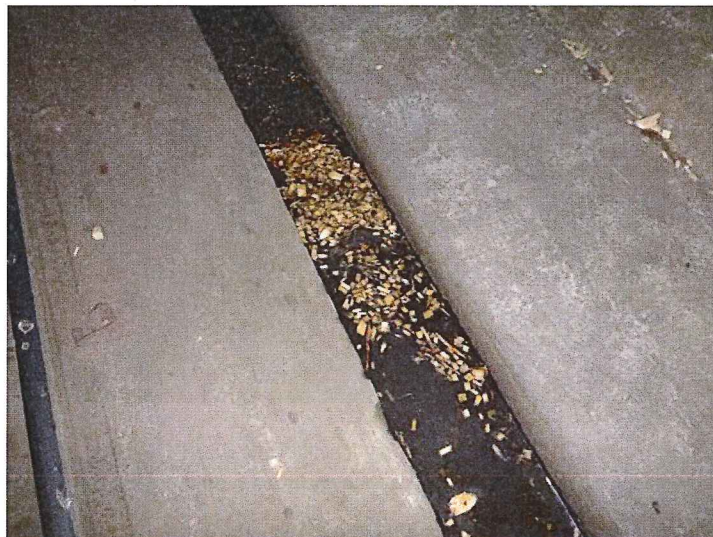
Figure 7: Debris in the tunnel

The AMP mentions that the amount of debris and abrasive agents entering the tunnel and being carried in the drain may increase with increasing freight volumes. These flows need to be controlled, and cleaning regimes need to be maintained. Programmes of inspection and regular cleaning of the drains and sumps, and so on, will assist in maintaining the drains.

We are aware wood chip wagons have recently been covered, and there is no debris coming off container wagons and the CET (coal) wagons are covered.

**The Review recommends** that a cost/benefit analysis be undertaken to ascertain whether it may be more efficient to de-bark log trains at source.

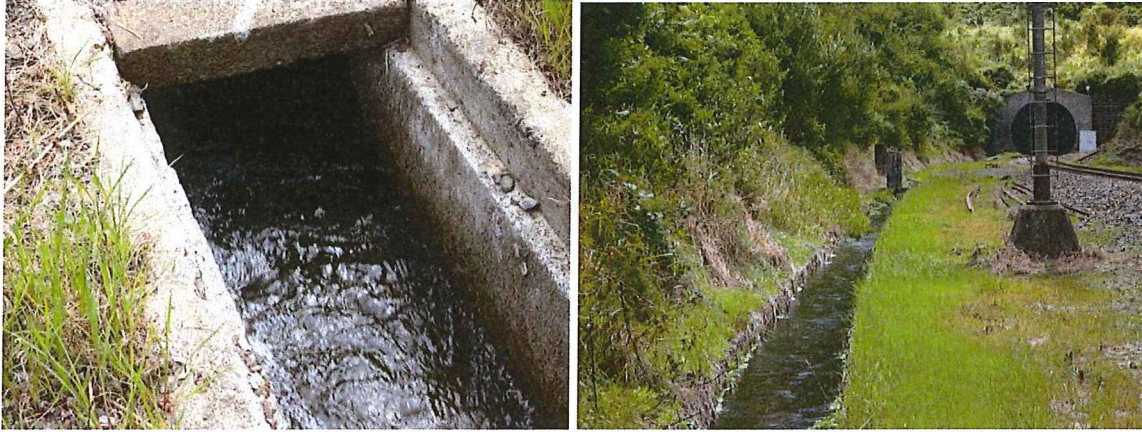
Figure 8: Drainage Hemopo end

The structural condition of the tunnel's drain was determined to be a category 2 (where '1' is 'best' and '5' is 'worst') in most places, with instances of category 3 and 4 every 100m or so (at the lower end of the circular profile).

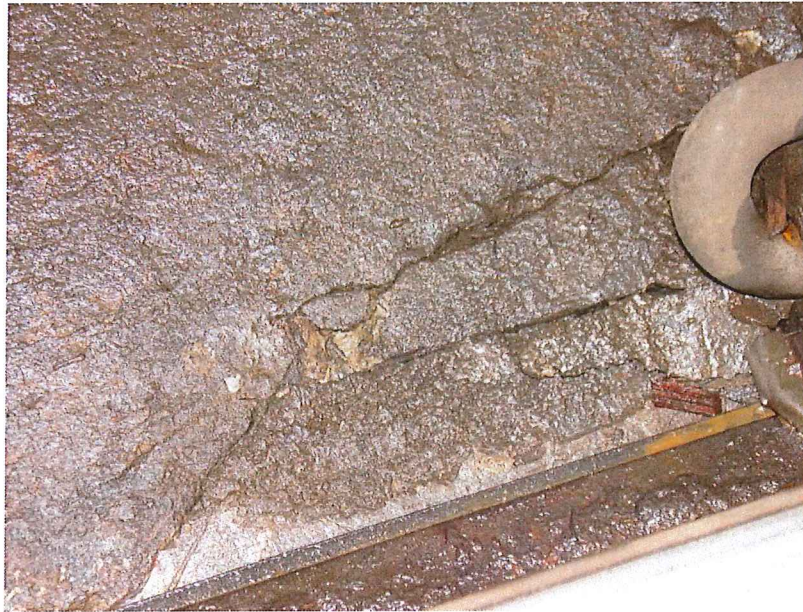
Figure 10: Slab cracking

The slab track condition can be summarized as follows:

Areas of poor condition are being addressed by grooving beneath the rail foot and maintenance of side drains to ensure they do not overflow and divert beneath the base slab.

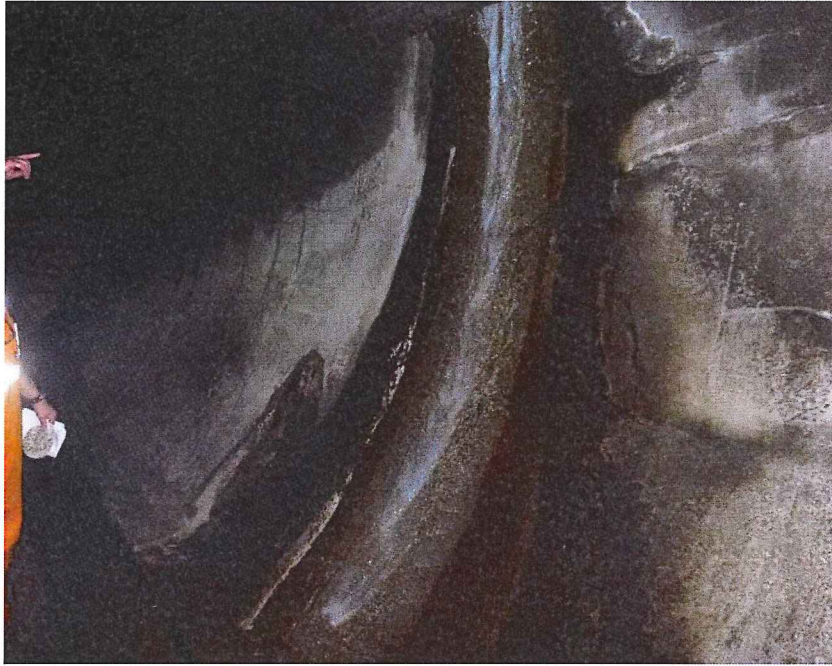
**Figure 11: Groundwater flow in tunnel**

The tunnel lining is between 35 and 45 years old. Some areas are opening up and significant groundwater flows are evident.

The following maintenance activities will manage the tunnel lining in future:
