# **REVIEW OF SAFE WORKING PROCEDURES FOR TRAIN OPERATIONS IN THE OTIRA TUNNEL**

**THE REVIEW IS A  
JOINT PROJECT  
SPONSORED BY THE  
KIWIRAIL SAFETY  
LICENSING  
MANAGEMENT  
TEAM AND THE  
RAIL AND MARITIME  
TRANSPORT UNION**

**Report written by  
HAZEL ARMSTRONG  
June 2012**

Final report to the Steering Committee: 30 June 2012  
Written by Hazel Armstrong, chair of the Working Group

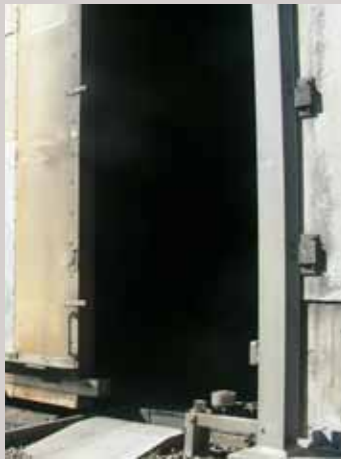
*The fans and door were installed in 1997.*

the DOL). In 1997 two fans and a door were installed at the western portal (the Otira end) to draw down the fumes emanating from the diesel locomotives. They serve to cool the locomotives and to clear fumes from the tunnel after the train has exited<sup>14</sup>. The hazards are being effectively controlled by the ventilation system, which is fans and a door, and the purging cycle of the tunnel. However, additional steps have been identified to further control the hazard. These steps are identified in the recommendations to this report.

There have been issues related to fan and door reliability.<sup>15</sup> The working group notes the data it collated and considers that fan and door failures still occur frequently. When this occurs the main defence against the fumes has failed, and emergency procedures must be followed.

- ★ *That a code specific for ventilation system failure be created for entering into IRIS; and a code be created for Otira Tunnel.*
- ★ *That KiwiRail install indicators outside the tunnel at both ends which indicates whether the fans and doors are functional.*

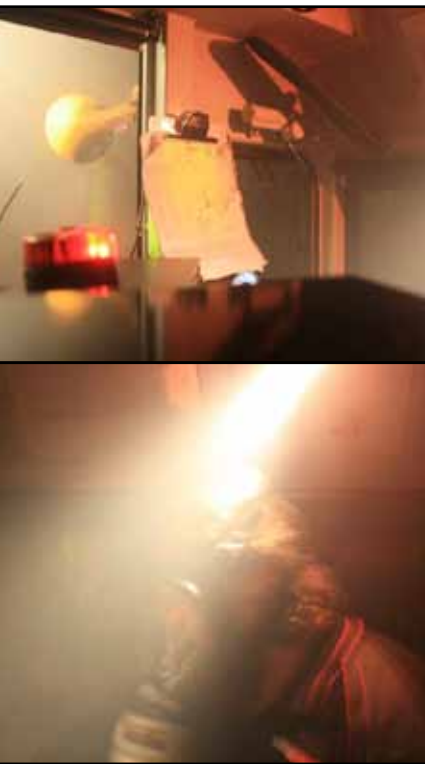
Testing during ventilation failures on 31 May 2012 showed exposures for all combustion gases and diesel particulates above the WES and the STEL when the driver was outside the cab. The testing shows that when outside the cab an exposure of less than 15 minutes would be sufficient to bring the biological exposure indices to 3.5%.

Fumes in tunnel during stall test.

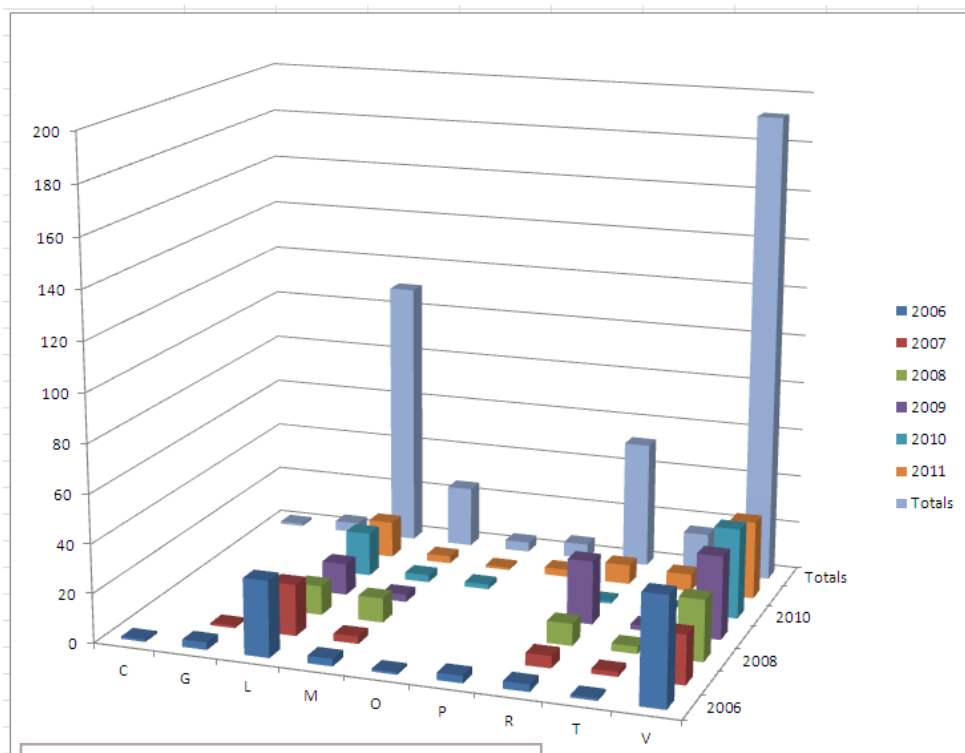
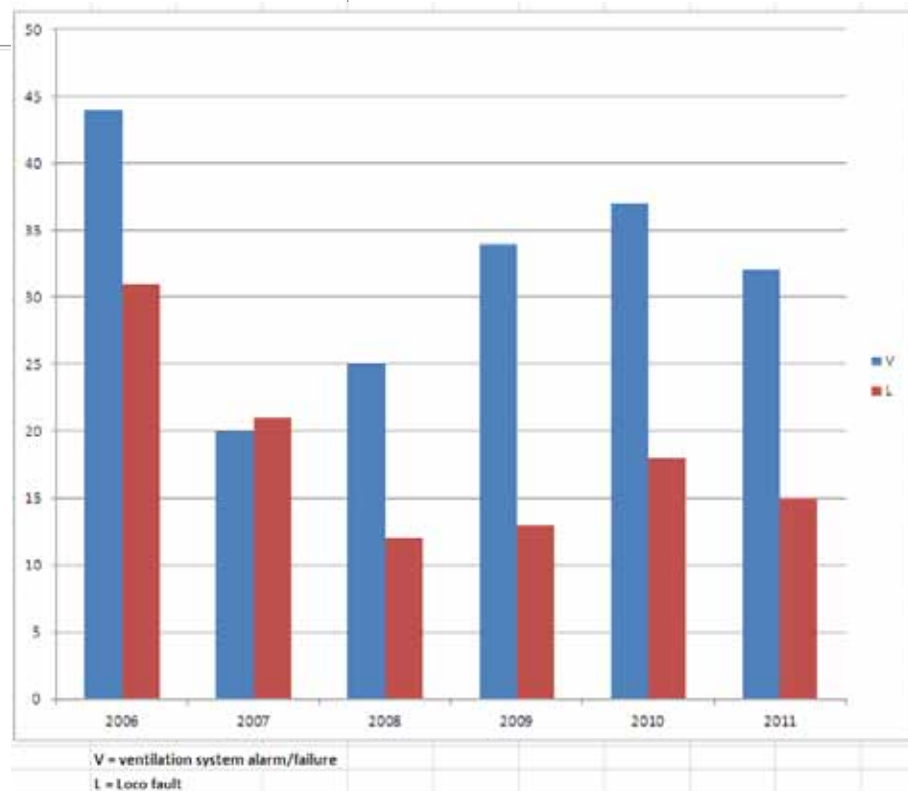
The working group observes that locomotive faults and ventilation failures are the prominent issues to address. These failures may be related. Locomotive faults have reduced over time, but ventilation failures remain persistently high.

**These graphs illustrate the incidents occurring in the tunnel over the past six years**
