# **REVIEW OF SAFE WORKING PROCEDURES FOR TRAIN OPERATIONS IN THE OTIRA TUNNEL**

**THE REVIEW IS A  
JOINT PROJECT  
SPONSORED BY THE  
KIWIRAIL SAFETY  
LICENSING  
MANAGEMENT  
TEAM AND THE  
RAIL AND MARITIME  
TRANSPORT UNION**

**Report written by  
HAZEL ARMSTRONG  
June 2012**

Final report to the Steering Committee: 30 June 2012  
Written by Hazel Armstrong, chair of the Working Group

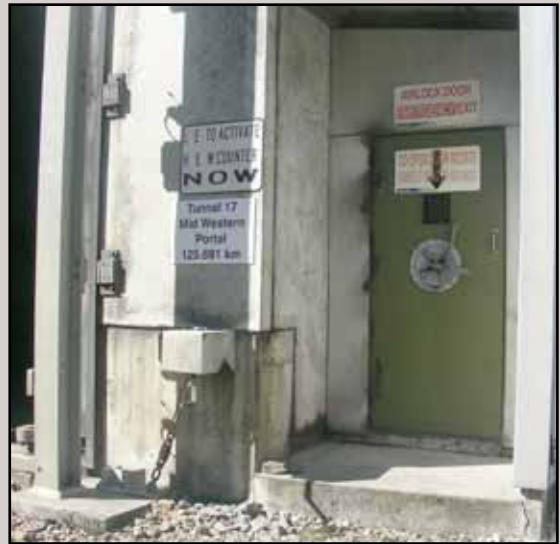
*The fans and door were installed in 1997.*

the DOL). In 1997 two fans and a door were installed at the western portal (the Otira end) to draw down the fumes emanating from the diesel locomotives. They serve to cool the locomotives and to clear fumes from the tunnel after the train has exited<sup>14</sup>. The hazards are being effectively controlled by the ventilation system, which is fans and a door, and the purging cycle of the tunnel. However, additional steps have been identified to further control the hazard. These steps are identified in the recommendations to this report.

There have been issues related to fan and door reliability.<sup>15</sup> The working group notes the data it collated and considers that fan and door failures still occur frequently. When this occurs the main defence against the fumes has failed, and emergency procedures must be followed.
